то	:	Dave Braithwaite, Steel Studio International
FROM	:	Nick Wright
DATE	:	25 th February 2009
SUBJECT	:	Balustrade Testing Department of Foreign Affairs.

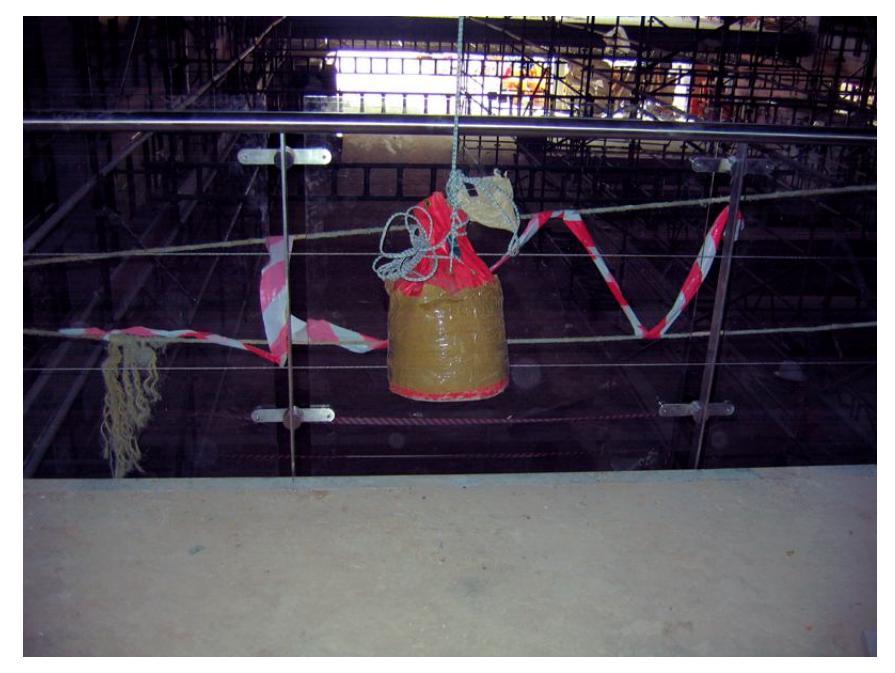
Sand bag impact test of 400 J to balustrade panel identified by yourself. Sand bag was overweight at 31 kg and dropped from a height of not less than 1.36 metres. Impact energy therefore exceeded 413 joules.

Impacts were made to the centre of the panel between the two wires (two impacts) to the bottom left corner on the bolted fitting, and as close to the top left fitting as possible. It was impossible to get as close to the top left fitting as the bottom fitting because the hand rail is in the way.

Image 1 shows swing bag position prior to the first impact.

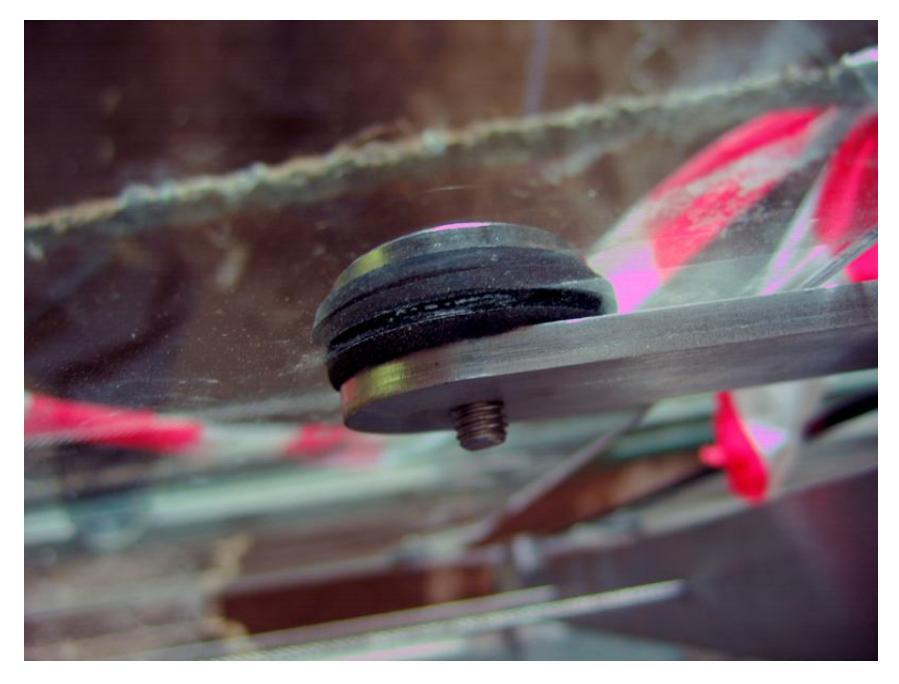
The isolation material between the stainless steel brackets and the glass is particularly thick and effective at preventing glass to metal contact. The final installation must have the same or better isolation.

Image 2 shows fixing and bracket detail after the first impact. Note the size of the isolation.

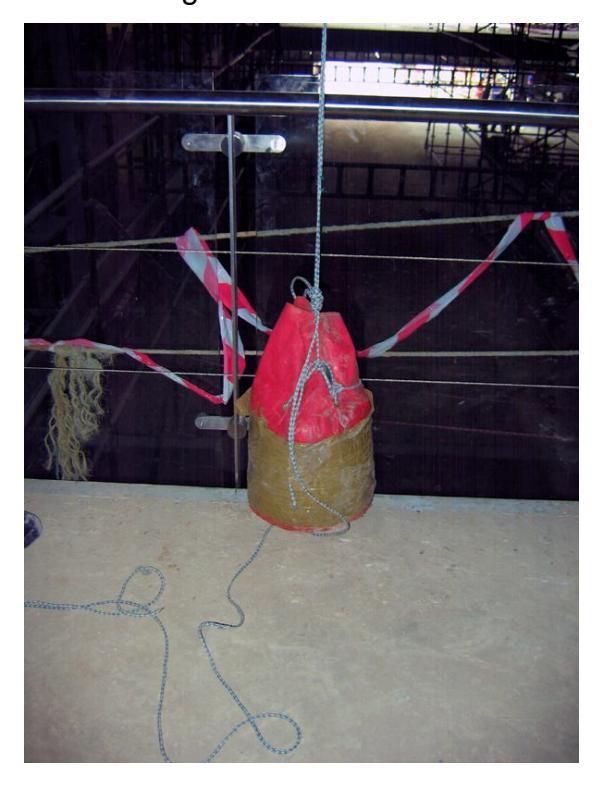
Image 3 shows the position of the swing bag for the impact next to the bottom corner fixing.

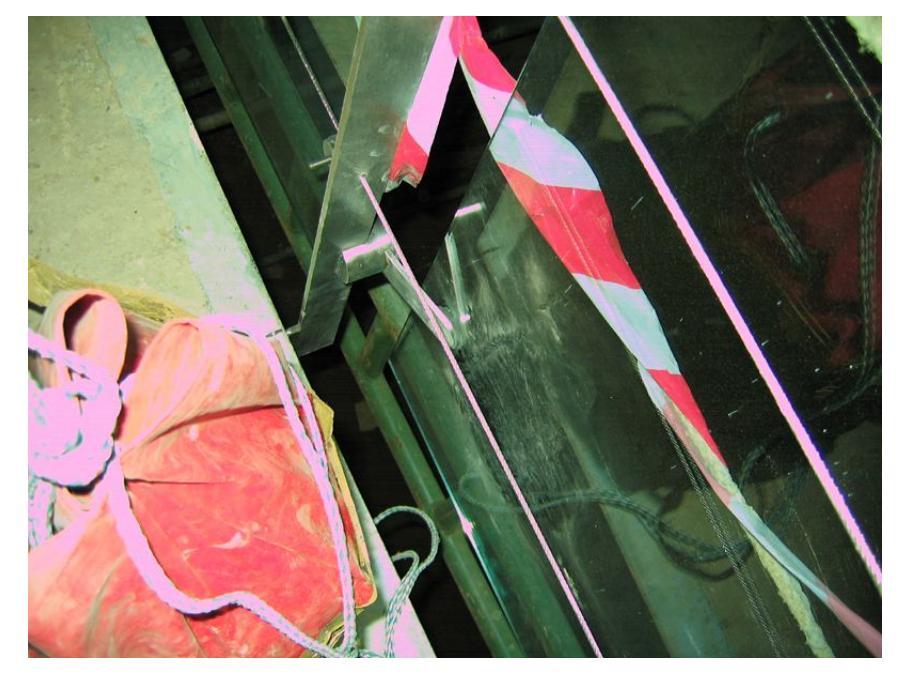
All four tests were completed without breaking the glass. The stainless steel brackets were permanently deformed however. Hand rail, stanchion and steel wires remained undamaged.

Image 4 shows the bent bracket after the impact on the bottom corner.

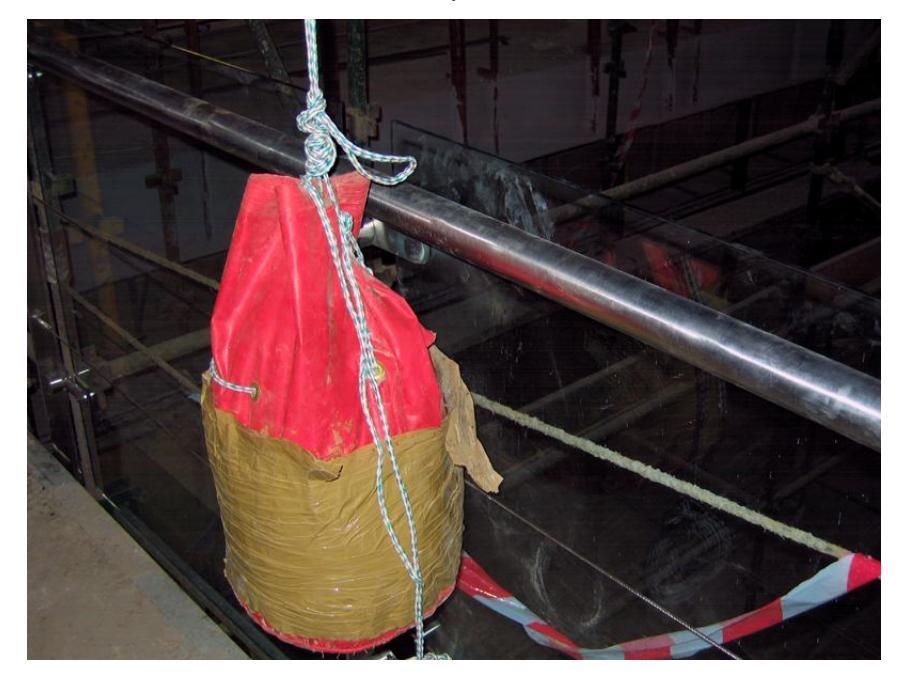
Image 5 shows position of the swing bag for the top corner impact. Note the position of the hand rail which precludes lifting the bag further and the top wire which will take some of the impact.

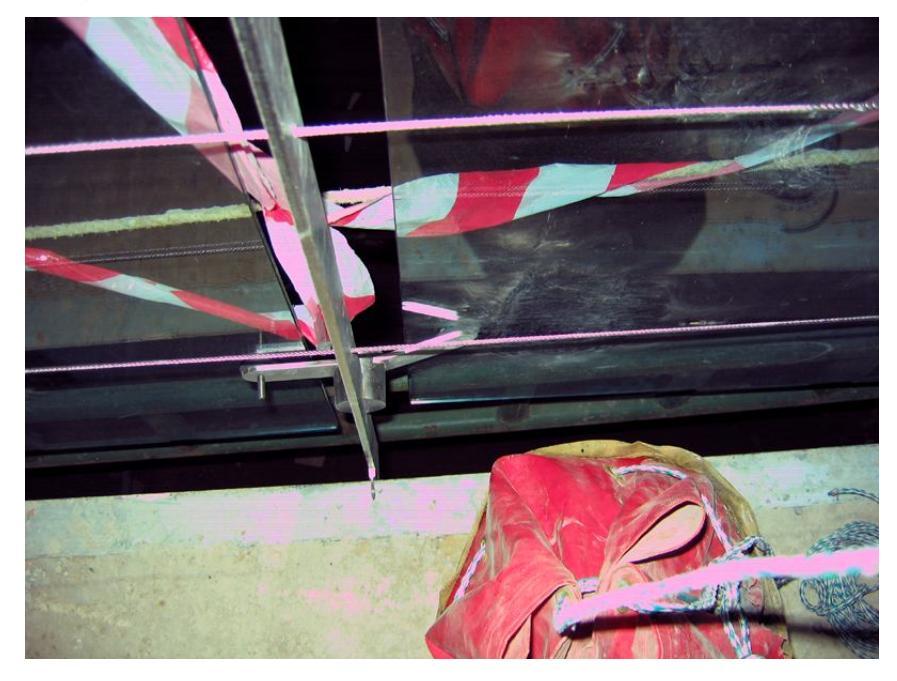
Image 6 shows the balustrade after the final test.
